Summary of experience with LHC and SPS IPM monitors in 2011 & 2012 (& 2013)

Mariusz Sapinski, CERN BE/BI

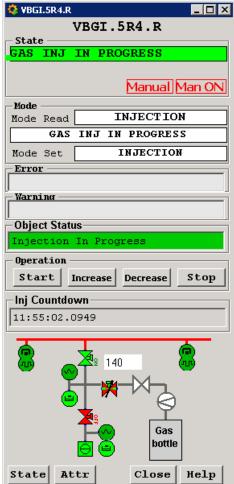
System: gas injection

- needed in LHC (normal vacuum 10⁻¹¹ mbar)
- gas injection up to 10⁻⁸ mbar
- PVSS application
- manual control (3-4 steps)
